# Technical Bulletin CS-08-03

## SpectraLink Rev B Handsets (6020 / 8020 / 8030)

SpectraLink 6020 Wireless Telephones  
SpectraLink 8020/8030 Wireless Telephones

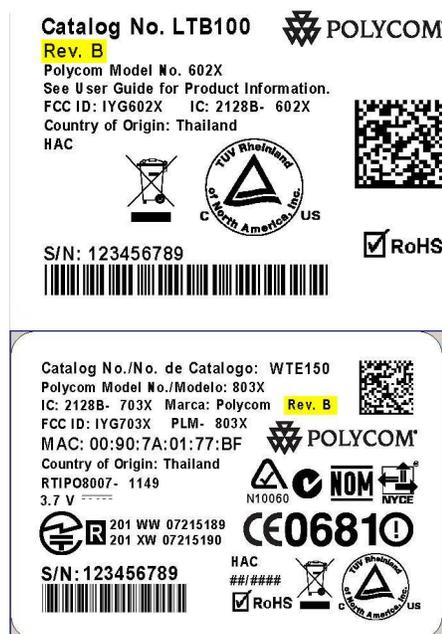
There has been an internal component change within the Link 6020 and the NetLink 8000 series handsets. While functionality has not changed, these phones will require a minimum version of software to operate. The hardware revision can be identified on the label on the back of the handset. The following diagram shows an example of how the label will appear. Specific handset models may vary, but they will be identified by the “Rev. B” indication as shown in the examples below.
