Technical Bulletin CS-10-11

SpectraLink 6300 Cards – Rev B Infrastructure

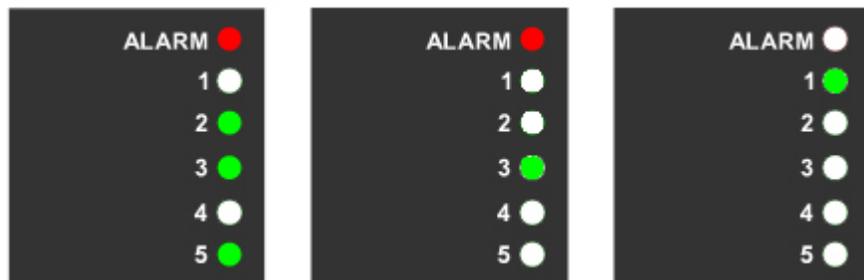
There has been a component software change that affects the SpectraLink 6300 Controller Cards. The changes are due to an identified timing issue within a component on the cards, and will not add any new functions or features. The cards can be identified by a revision label on the front panel. They will be labeled “Rev. B” (see example below).

The LEDs on the front panel of the “Rev. A” card that is experiencing the errors would go through the following sequence: LEDs 2, 3 and 5 begin lit (green) along with the red ALARM LED. Then LED 3 being lit (green) along with the red ALARM LED, followed by LED 1 being lit (green) with all other LEDs being off. This cycle will repeat continuously with approximately 2 second pauses between LED patterns.

If you are experiencing the errors described please contact your support representative to discuss options. It may be necessary to replace the “Rev. A” controller to obtain a “Rev. B” controller to resolve the issues.
