Technical Bulletin CS-08-13

SpectraLink 8000/6100 Leakage Current

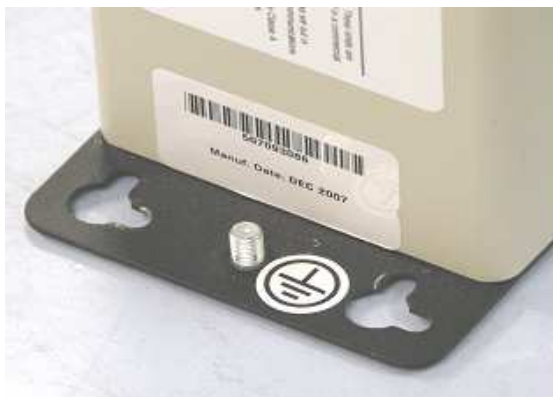
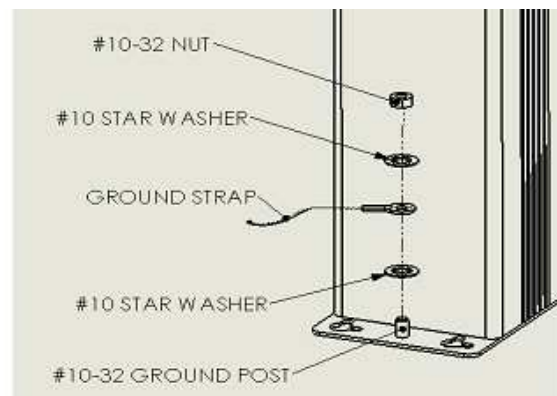
The SpectraLink equipment listed above are contained in a metal chassis that may contain leakage current (i.e., “touch” current) when connected to the power supply. This leakage current is cumulative when multiple units are connected together to form a larger system. Excessive leakage current can cause a shock when touched.

To prevent the buildup of leakage currents from being present on exposed metal surfaces, the units must be properly grounded to a protective earth ground by means of the grounding stud located on the rear panel (see illustration below). This **MUST** be done to all units before they are powered up.

No more than 15 units may be grounded though one connection to the protective earth ground. Systems with more than 15 units must be separated into groups of 15 or less with each group having their own independent protective earth ground connectors.

Once all units have been properly connected to an earth ground, they can be powered up (using only the provided Class II AC Adapter with an output of

24VDC, 1A). Verify that the leakage current on exposed metal surfaces does not exceed 250 μ A rms. If it does, then power off all units and re-verify the grounding connections.
