**Tech Bulletin CS-06-07**

Phone case appears to have stripped screws

**Hardware Revisions:** Link PTB-400 and PTB-410 Phones

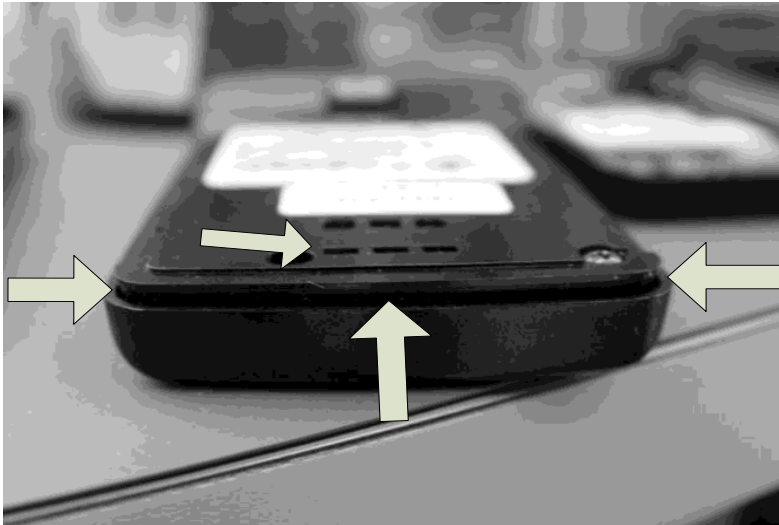
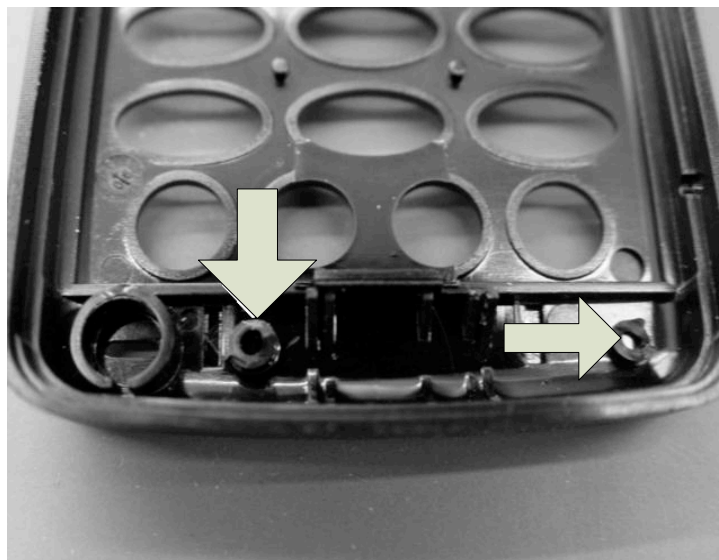
Link PTB-400 and Link PTB410 phone case opening at bottom, potentially causing intermittent power problems.

A plastics weakness has been identified in a small percentage of Link PTB-400/410 handsets manufactured between January 2006 and July 2006. The bottom plastic bosses that receive the screws used to hold the two outer cases of the phone together may fracture when the phone is dropped. When this happens, the screws can no longer grip into the boss and the bottom plates of the phone may open slightly. This in turn can cause the phone battery contacts to dislodge and may lead to intermittent power problems.

The arrows on the left, right and bottom point to where the phone casing can separate. There is no longer a solid tight fit. The other 2 arrows in the center show where the battery contacts may be missing.

Affected phones must be replaced. SpectraLink will issue advance exchange replacements for any affected handsets.
