Spectralink 75-76-77x2-Series

Technical Release Notes R3, 2022

Firmware Version PCS 22D

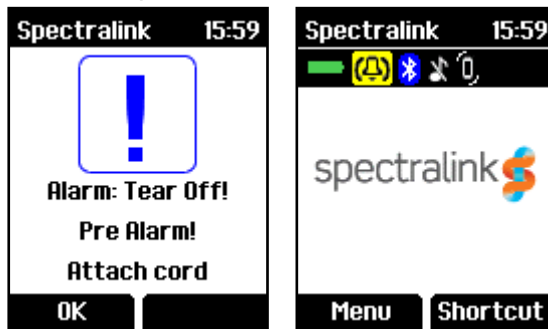
- Alarm user settings for Tear-off string, Running detector and Man down detector, in the advanced settings menu, now includes the settings: Off, Send MSF, Speed dial, Pre alarm and Loudspeaker for Speed dial.
- Alarm user feedback and notifications improved. Alarm notifications will now be shown as long as the user has not confirmed with “OK”. Pre-alarm will keep notifying every few seconds as long as the pre-alarm condition is not resolved. The notification includes name of the pre-alarm type and instructions for disabling it. Furthermore, a yellow bell indication icon is shown at the home screen, as long as an alarm notification is active. See example for tear-off below:
