Spectralink 76x0- and 77x0-Series

Release Notes Q3, 2016

Firmware Version PCS 16C

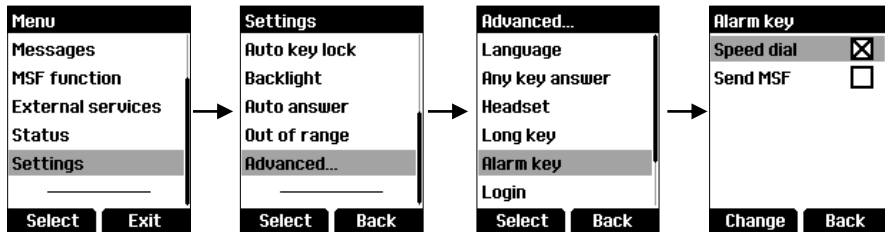
- An entry in the phone book can be assigned to a long key press on the alarm key. First the alarm key must be configured to use speed dial, see below.

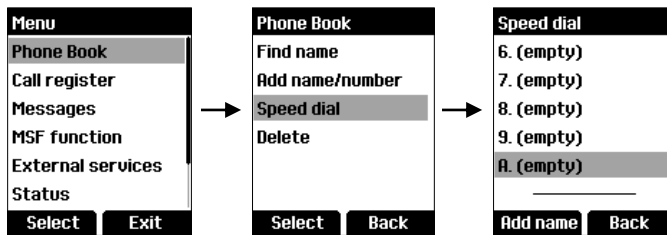
Then speed dial entry "A" must be assigned by selecting Add name:

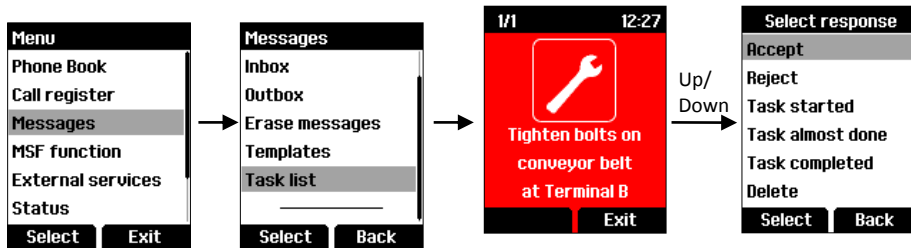
- A menu has been added to access the XML-RPC *endpoint_sms_advanced* Task list.

In this example, the Task list has been populated by a messaging application. Pushing up/down on the navigation key will enable the user to select a response. For easy access to the Task list, this entry has been added to the Shortcut list.
